TR-959

AN INVESTIGATION OF THE DYNAMICS
OF THE ELECTROLYTE DISTRIBUTION SYSTEM
IN THE PS502-502A POWER SUPPLY

24 July 1961

DIAMOND ORDNANCE FUZE LABORATORIES
ORDNANCE CORPS • DEPARTMENT OF THE ARMY
WASHINGTON 25, D. C.

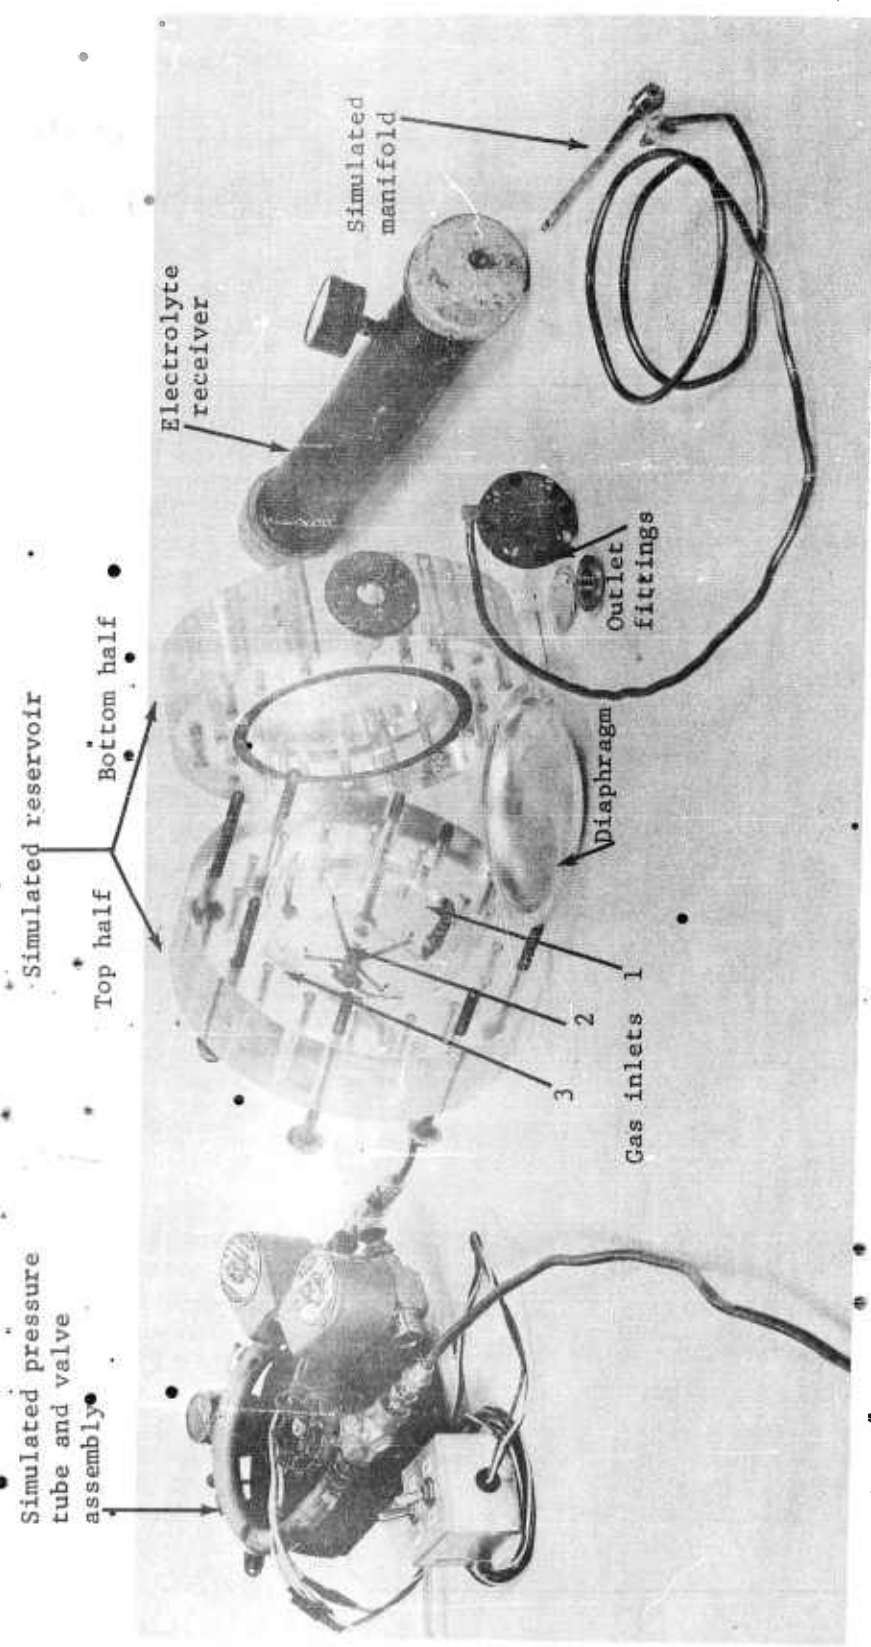
Figure 8. Experimental setup A, disassembled.

2.1 Setup A. Two lucite discs, 7.50 in. in diameter and 2.0 in. thick were constructed with one face of each machined to the same curvature as the inner surfaces of the reservoir (fig. 8). Inlet and outlet holes were drilled, and suitable fittings were attached. (Several inlets are shown in figure 8; only one was used at any one time and the unused ports were blocked.) The diaphragm is clamped by its rim between the flat surfaces of the lucite discs and rests in the upper half of the simulated reservoir.

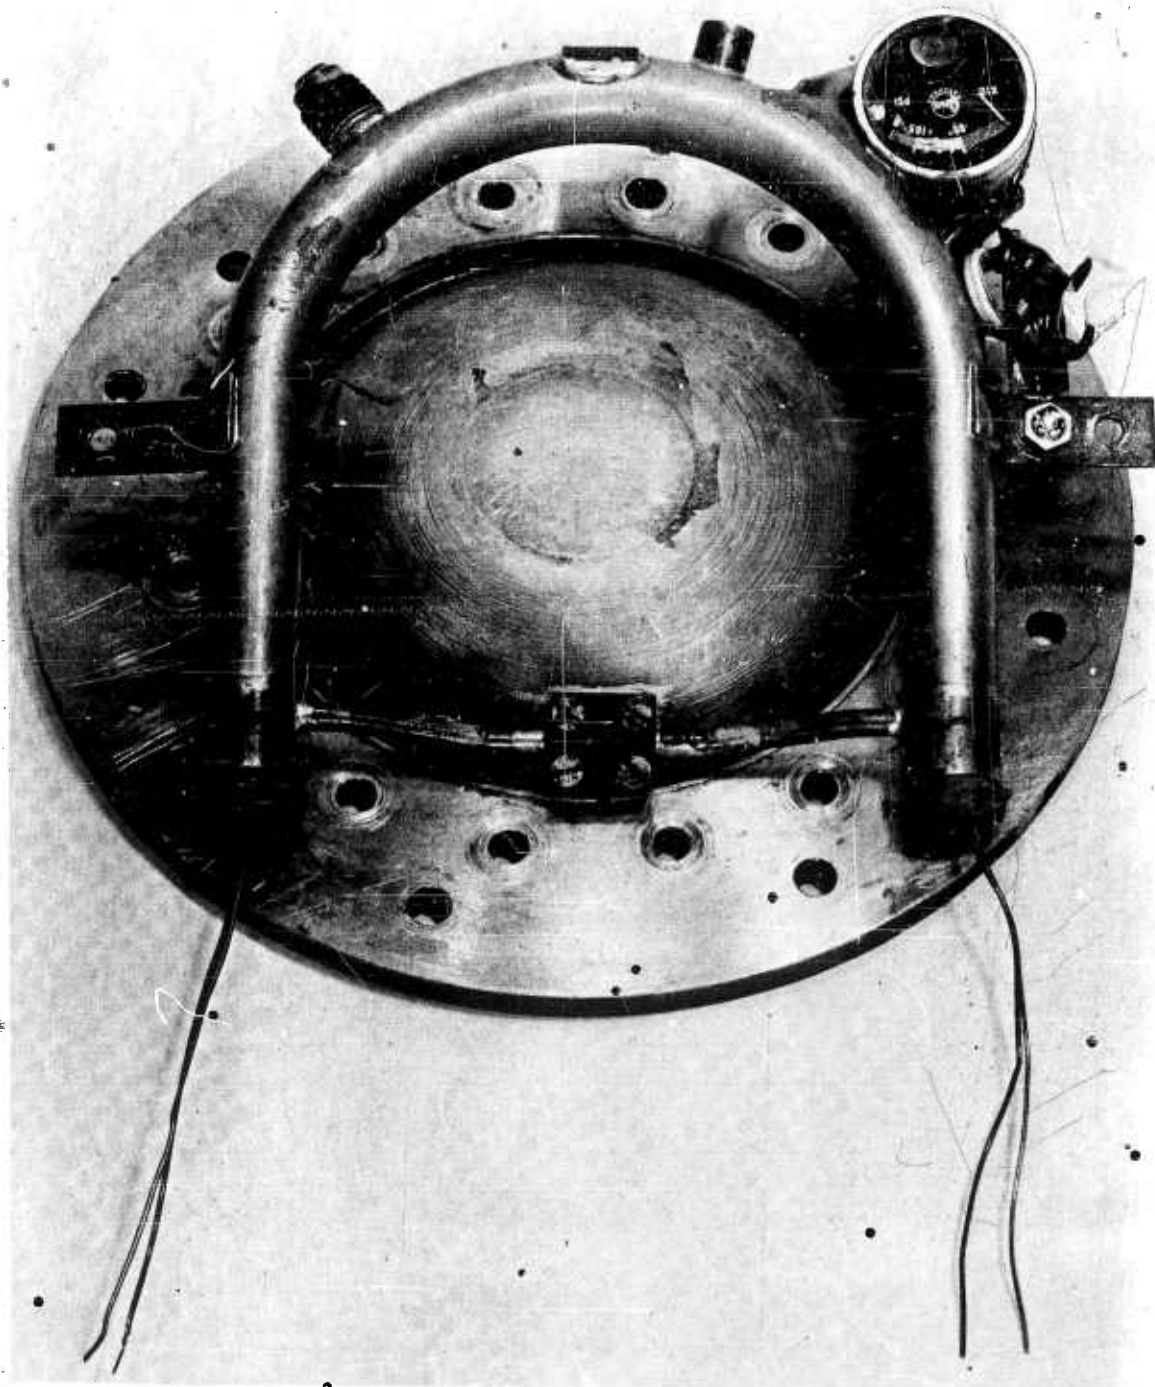
Figure 9. Top half of simulated electrolyte reservoir, with battery activator (setup B).

2.2 Setup B. To simulate the reservoir more closely, the top lucite disc was replaced by a metal upper half. Figure 9 shows the upper half with an activator mounted on it. Photography now had to be from the liquid side. The exit port was moved from the center of the lower half to one edge, out of the field of view (fig. 10 and 11). The metal electrolyte receiver was replaced with a transparent one so that flow rates could be measured. A clock was included, and the diaphragm, electrolyte receiver, and clock were photographed together. Films made with this setup were of higher quality because smoke from the squibs could not obscure the view of the diaphragm.

A number of experiments were performed in which the diameter of the gas inlet was reduced. The connector on the activator (fig. 9) was milled and a small brass disc containing the orifice(s) was pressed into the recess. The purpose of this modification was to reduce the extremely high-pressure blast of the activator squibs. The peak pressure at the gas inlet before diaphragm and electrolyte displacement takes place is calculated to be 7000 psi. This pressure is quickly dissipated as the gas cools and expands into the reservoir, but not before the diaphragm is stressed and begins to fold improperly.
